TALL EL-HAMMAM

Southern Jordan Valley, Jordan (E. Kikkar)

SEASON FIVE, DEC 2009/JAN 2010

Views of the Bronze Age Fortifications

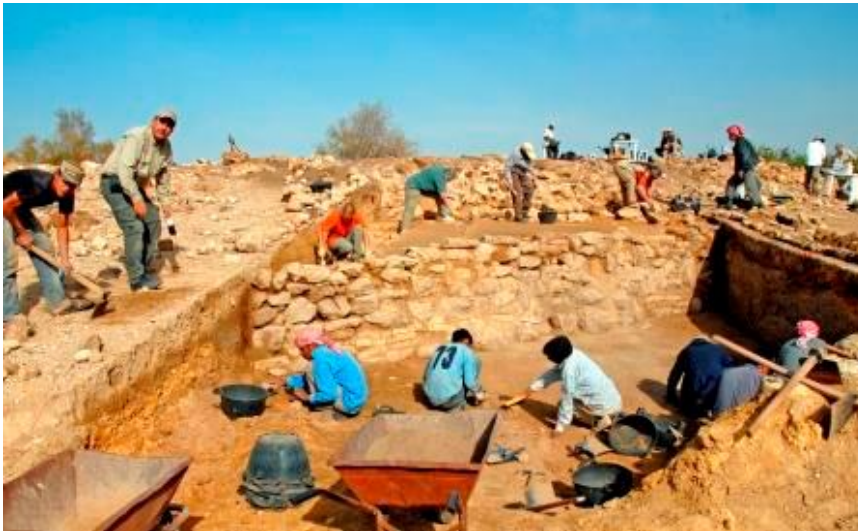
With an settlement platform in excess of 40 hectares (most of which lies behind massive, complex, multi-period fortification systems) and with an abundance of towns, villages, and hamlets within a .2km to 4km radius of influence, Tall el-Hammam was the epicenter of a significant city-state that dominated the region (likely) from EB1 through MB2, seemingly with little or no occupational breaks. Visible is the 5m-thick EBA city wall, with the 4m-thick MBA city wall just behind it on the horizon. In this photo, the fortifications in Trench LA.28 on the lower tall get a good cleaning before a photo shoot. Below are a few pictures from that shoot-around of locus photos.

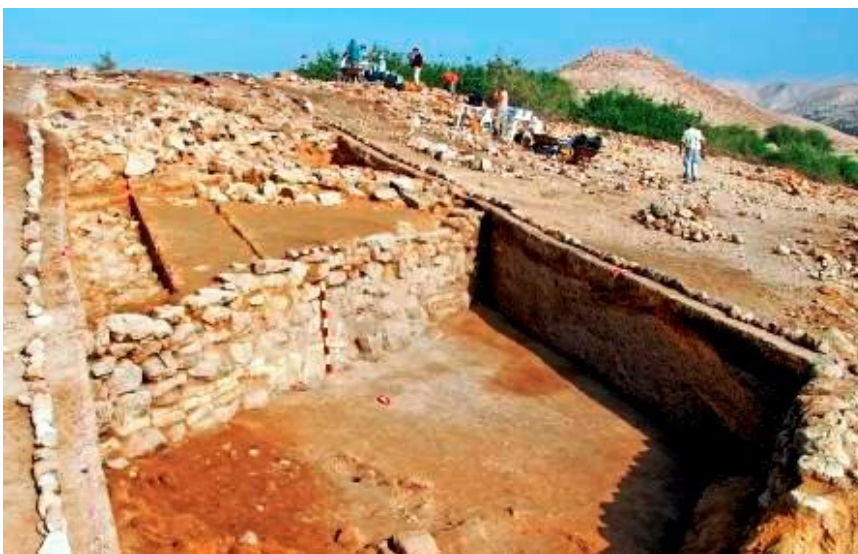
Here (looking NNE) you see the outer face of the southern EBA city wall which, thus far, reveals two distinct building/refurbishing phases. Each 5m-thick stone foundation phase is topped by a mudbrick superstructure, clearly visible on top of the final phase, and toward the bottom of the exposed face of the later phase. Sealing against the outer face is a street surface consisting of an extremely hard-packed matrix of clay, tiny pebbles, and bits of broken pottery. To the left, on that surface, you can see destruction debris, mainly mudbricks from the wall. The surface extends to the right underneath the (MB2 ?) curtain/revetment wall to the extreme right of the photo. The revetment wall may once have stabilized a glacis connected to the MB2 city wall just beyond and above the EBA wall. The upper tall rises to the E.

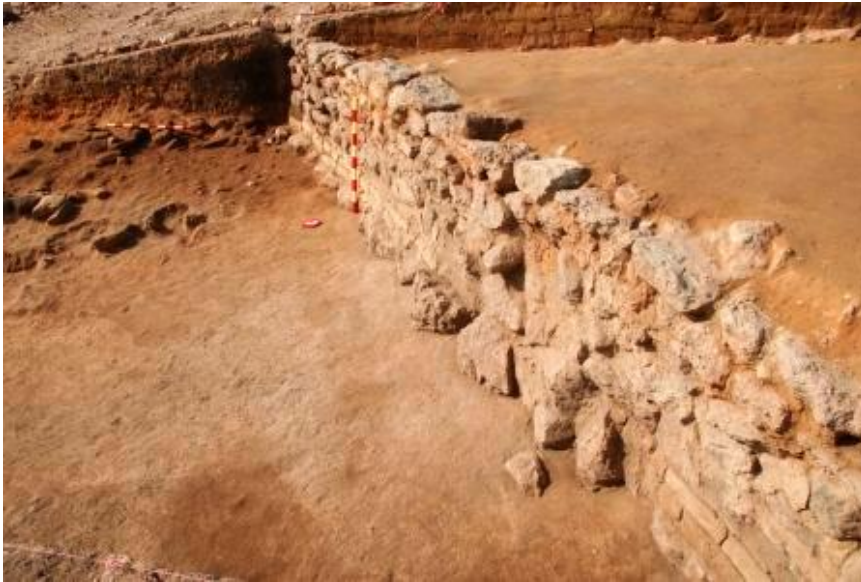
Here you can see the two phases (so far) of the EBA city wall (view W). Both the earlier and later phases are topped by mudbrick, visible atop the wall in the far balk and just below the stone courses of the later phase in the outer wall face. Plaster still adheres to the stones of the outer wall face in many places. At the far end of the exposed street surface, mudbricks from the collapsed EBA wall are visible. Due to the fact that EB1, EB2, EB3, IB1-2, and MB1 pottery sherds were present on the walking surface and mixed into the thick debris matrix overlying it, this wall and street may still have been in use just prior to the construction of a new wall and associated glacis during the mid-MBA. The MBA builders may have filled in this area which then provided a firm substrate for their glacis which then covered this space. The E balk reveals layers and lenses of fill that seem purposefully placed.

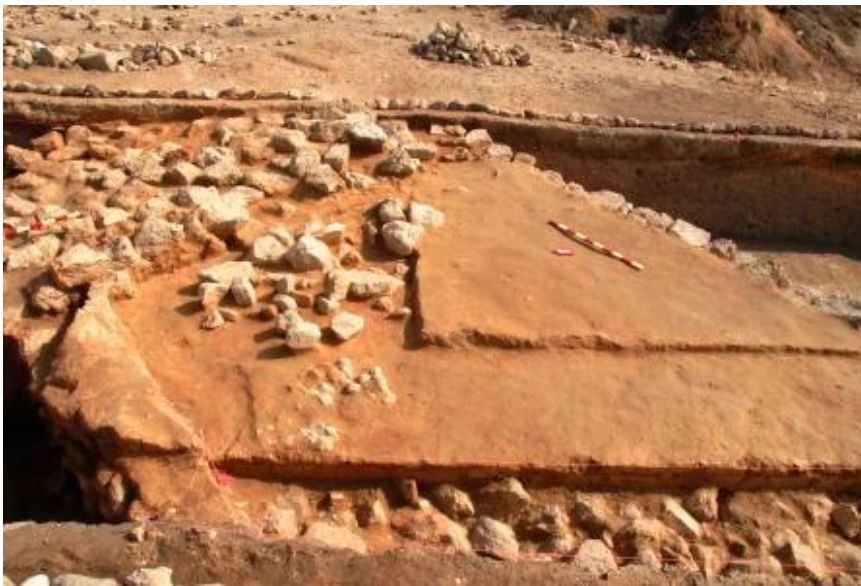
This is the EBA city wall in Trench LA.28 looking E. The wall width (thickness) is just over 5m. It is constructed of mono-sized, one-man, undressed field stones, typical of EBA wall construction. Here you can see the full width, with the inside face to the left and outside face to the right. The sub-balk in the foreground reveals that the stone foundation is constructed consistently from face to face. The visible brown material on top of the foundation is mudbrick. At the far end of this portion of the wall is a tower foundation laid square to the wall faces. It seems to be built over one or two mudbrick courses and not tied to the stone foundation itself. We still have to clarify this. The unorganized stones just to the right of the tower courses have tumbled from the tower, along with a slurry of cobble-sized stones that may have been a surface associated with the tower.

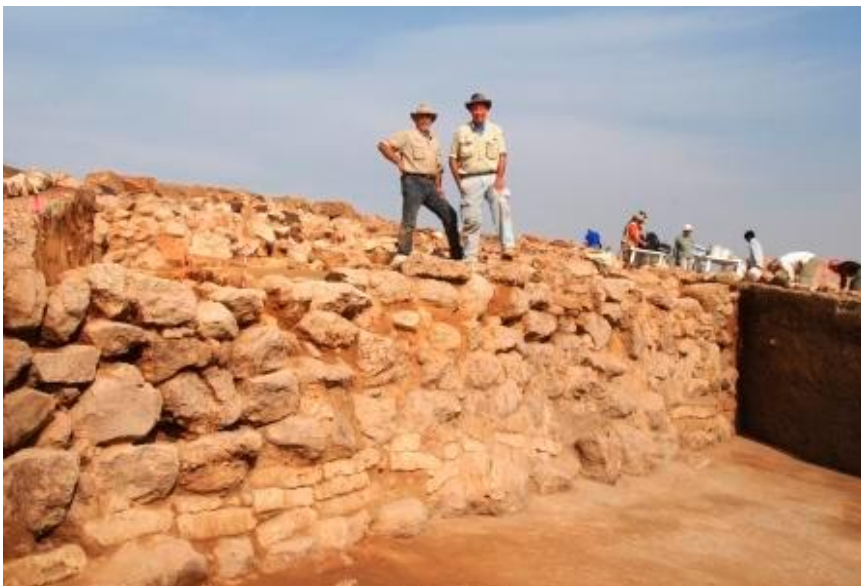
Here you can clearly see the topping mudbrick courses from the earlier phase of the wall. These bricks are extremely hard. After the re-builders had scraped away the looser materials, these few mudbrick courses were evidently considered solid enough to build their new stone foundation phase upon them. Indeed, these bricks are, even now, neither cracked nor crumbling. This wall is traceable, as is the main MBA city wall, around most of the site. Some sections have been bulldozed away for farming. We've still got five weeks of excavation to go, so much more will clarify in this area as we continue. Surely, there will be many surprises!

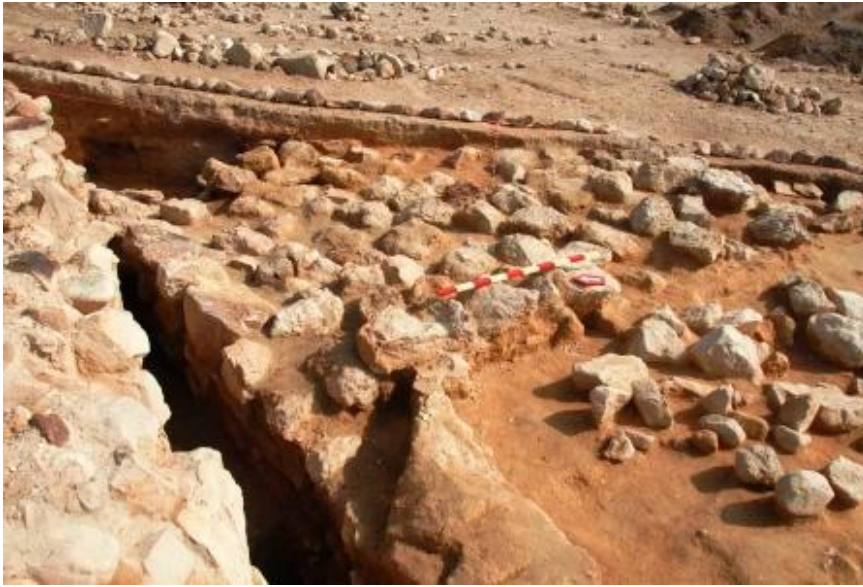
The meter-stick is sitting on the tower stone courses which are built over the EBA foundation, and actually cut into the mudbrick courses atop the foundation proper (in situ mudbricks are visible in the immediate foreground). The question is: Was this an IBA/MBA rebuild or an original part of the final EBA wall phase? That it seems to float over one or two mudbrick courses (which seal against the EBA foundation) is suggestive that this tower was either an EBA afterthought or an IBA or MB1 addition. I think we'll figure this out in the course of things as the sequencing unravels, and as we perform a full coring of this wall for purposes of phasing. You can see the MBA wall to the left. This wall is 4m thick here, but up to 8m thick in another location about 200m to the west.

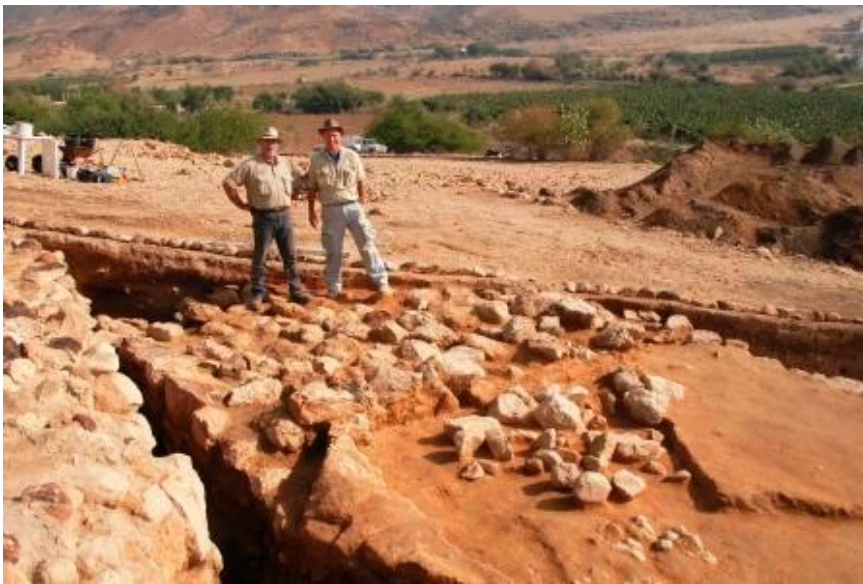
Here I am (left) with Gary Byers standing on the tower foundation. The wall extends behind us to the trees in the background. Beyond that you can see banana fields. To the immediate left of our dirt pile (at the right) you can see stones that are a part of the curtain/retaining wall that extends several for several hundred meters parallel to the southern MBA city wall. It may have footed the MBA glacis, which has almost entirely eroded away. Perhaps much of it has been bulldozed away as the site was leveled for farming. However, we now know of several places where it may be preserved substantially, and we also think we know where at least one of the main MBA gate complexes is located in the same area. It's a massive system of walls, towers, and many unidentifiable structures, and will take us many years to excavate.

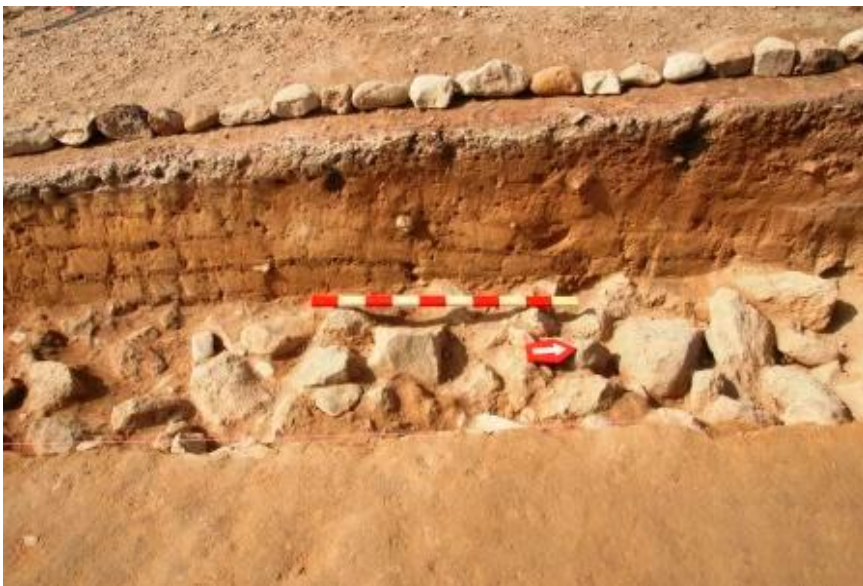
Here you can see 4+ courses of mudbrick laid over the final stone course of the EBA city wall foundation. In the immediate foreground you can see more of the mudbrick superstructure. The sub-bank was created to reveal how the first mudbrick course sealed against the stone substrate.

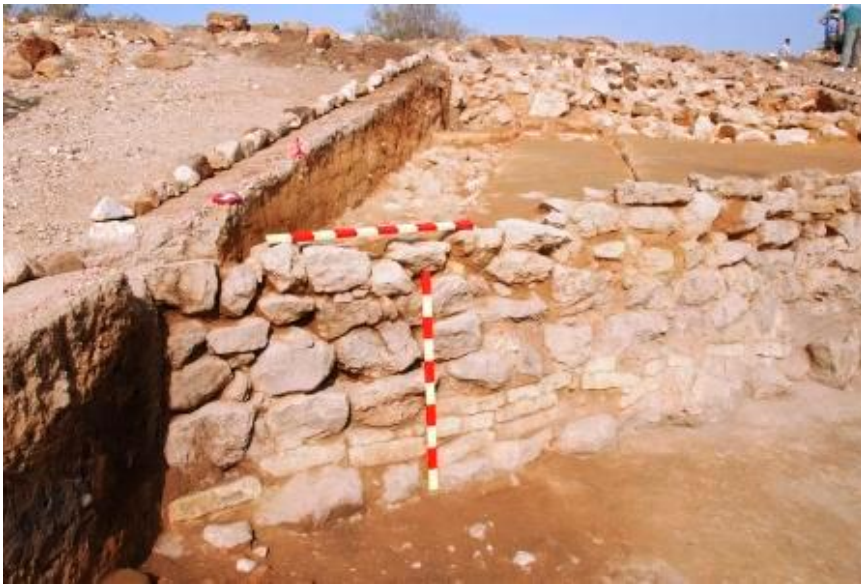
The MBA city wall is behind (N of) the EBA wall, and running parallel to it over the 300 or so meters where we can trace them both on the S side of the lower tall. The EBA wall was, then, underneath the MBA glacis, but not underneath the MBA wall. Why the MBA builders didn't build their 4m-thick city wall directly over the 5m-thick EBA city wall is a little mystery that we hope to resolve at some point. Due to the presence of EBA, IBA, and MBA pottery directly on the street surface associated with the two now-exposed EBA wall phases, we surmise that the EBA wall and street were still in use up until the time the MBA wall/glacis/revetment fortification system was built. This idea is reinforced by the presence of ceramics from every phase and sub-phase of the EBA, IBA, and MBA all over the site, and in several excavated Bronze Age contexts on both the lower and upper tells.

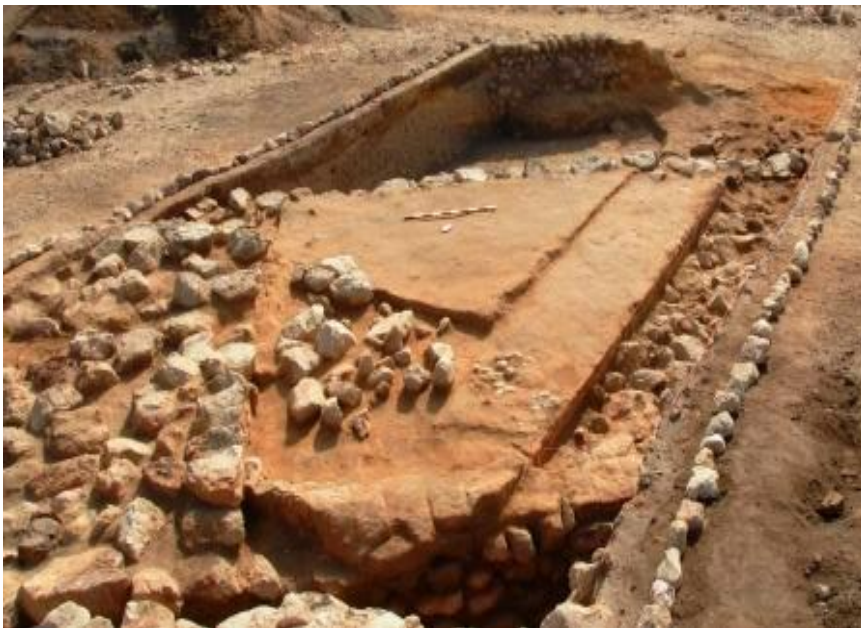
This photo was taken standing atop the MBA city wall looking SE (the stones cut off along the bottom edge of the photo belong to the MBA wall). You can clearly see the tower foundation dug into the mudbrick superstructure of the EBA wall final phase. The outer (S) face of the tower foundation does not extend to the outer EBA wall-face, but stops about 60cm short of it. But it is flush with the N EBA wall-face. The character of the tower masonry is fundamentally different from the stone construction of the EBA wall proper. From this angle you can see a section cut through the mudbrick revealing the top of the stone foundation below. At the far end of the trench (intersected by the E balk) is the curtain/revetment wall that we think retained the bottom of the MBA glacis. Thus, you can extrapolate the glacis from there to about the forehead of the photographer standing on the MBA city wall foundation.
